UNITED STATES COAST GUARD

INVESTIGATION INTO THE CIRCUMSTANCES
SURROUNDING THE SINKING OF THE

TUG VALOUR

40 MILES OFF THE COAST OF WILMINGTON, NORTH
CAROLINA ON JANUARY 18, 2006 WITH MULTIPLE
LOSS OF LIFE

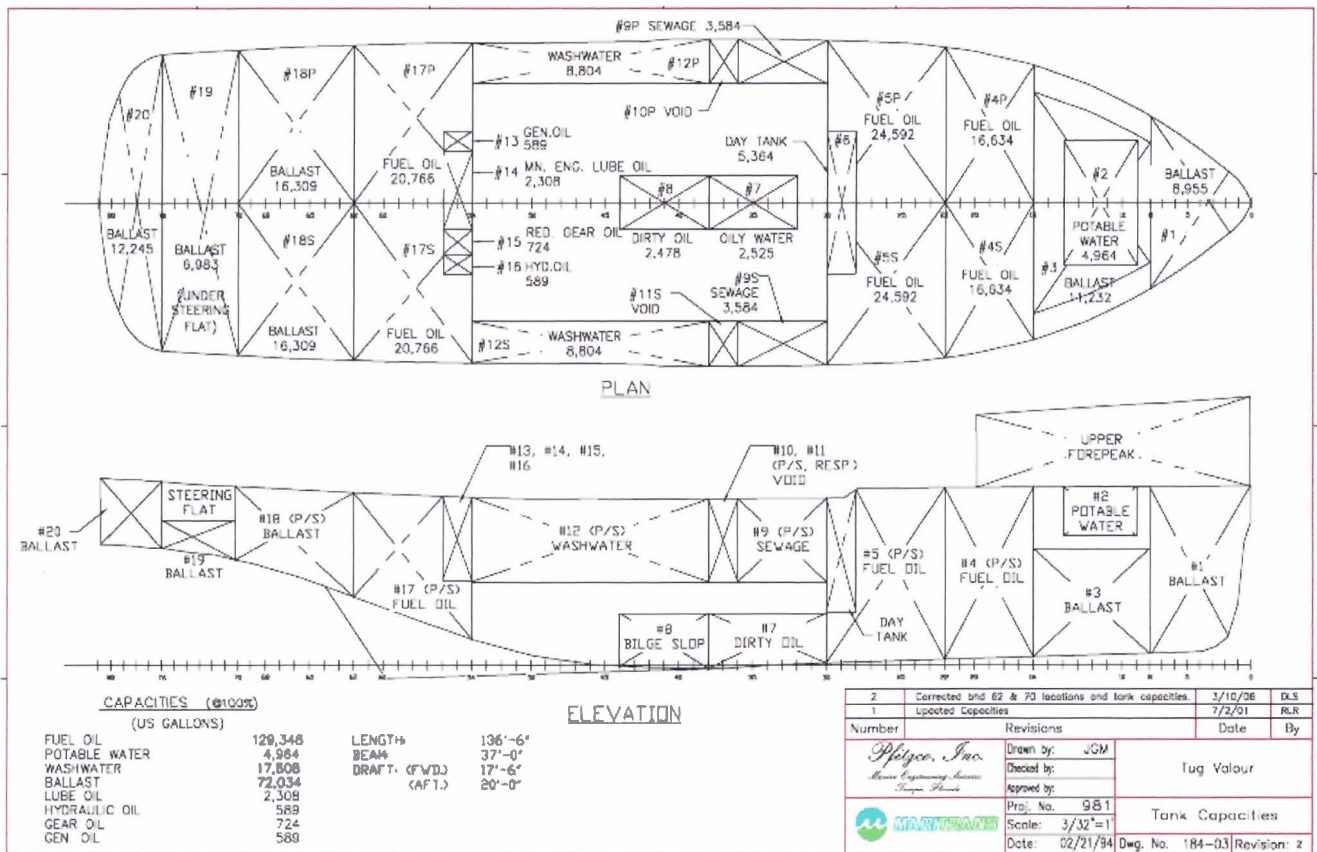
Corrected Tank Capacities Plan

5. The master and crew of the VALOUR relied on an incorrect tank capacity plan provided by Maritrans Operating Company, LP, the operating company of the VALOUR, for referencing tank capacities for ballasting and fueling. This plan dated February 21, 1994, had the #17 port and starboard fuel tank capacities at 15,683 gallons each and the #18 port and starboard ballast tank capacities at 8,483 gallons each. The Coast Guard received a corrected tank capacity plan after the VALOUR sank. The corrected capacities for the #17 fuel tanks were 20,766 gallons each and the #18 ballast tanks were 16,309 gallons each.

Recommendation 10: It is recommended that OSG – Maritrans conduct an internal review to ensure that all of their vessels' plans are accurate and up to date.

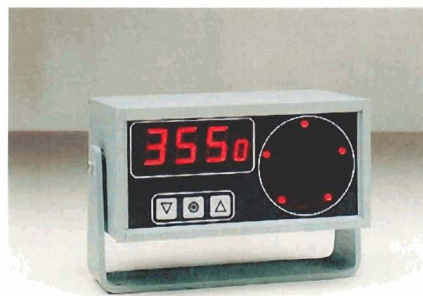
LR40 (same gyro digital display unit found on the VALOUR)

Therefore, regardless of whether this is the result of maneuvering to locate the man overboard or a loss of spatial awareness, it is likely that the VALOUR was transiting on a course of 103 degrees true with a "Signal Alarm from Gyro Compass" causing the display to flash.

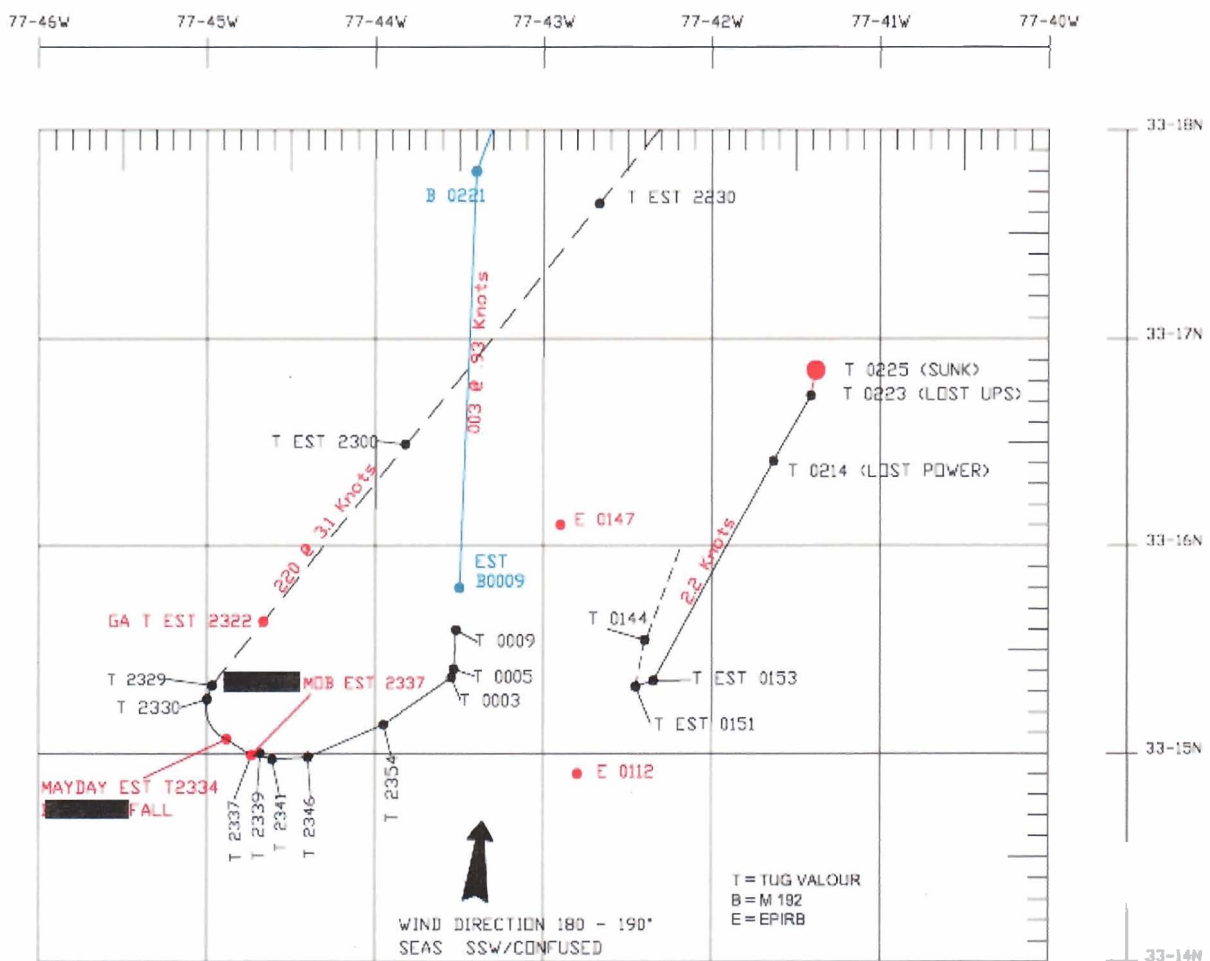
The VALOUR's trackline shows that it began tracking to the east shortly after 2330, and from 2337 to 2346, was on a course made good of 093 degrees true. There is speculation as to what the VALOUR's heading was as Capt [REDACTED] stated that he was heading into the wind and seas. From 2330 to 2354, the VALOUR went a distance of approximately 1 nautical mile during the

24 minute timeframe on a course made good of 102 degrees true which could easily be accounted for on a course of 103 degrees true at 3 knots. It is however very unlikely that the VALOUR would drift 1 nautical mile east when she was heading into winds and seas coming from due south. The winds and seas coming from the south could not have had such an eastward effect on the VALOUR without a significant port heading change. Additionally, barge M 192 was being towed 500 yards behind the VALOUR and was subject to the same winds and seas. Once the tow was released, from 0009 to 0221, with only winds and seas exerting force upon it, the barge drifted on a course of 003 degrees true at approximately 1 knot.

Tracklines of the VALOUR and Barge M192 (via transponders on each vessel)
