Abrasion and Twist Effects on High-Performance Synthetic Ropes for Towing Applications

Kris Volpenhein, Application Engineer
Rafael Chou, Vice President of Research and Development
Samson Rope Technologies, Ferndale, WA 98248, USA

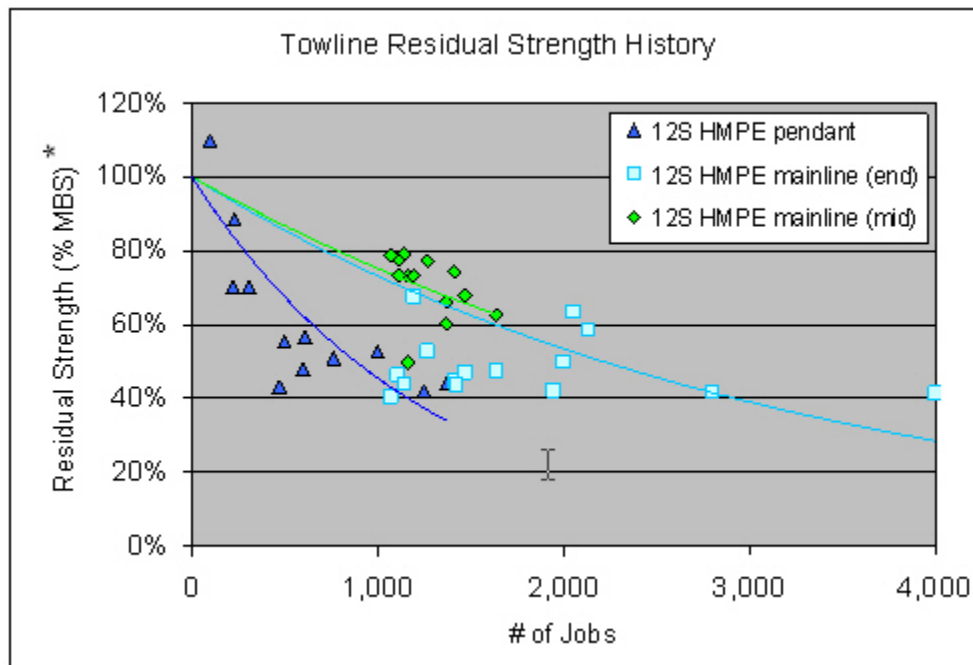
Figure 1. Residual strength history of similar sized ropes similar sizes performing similar jobs in harbor-class tractor tugs in Puget Sound and Southern California. (*MBS = minimum breaking strength.)[3]

Among all marine applications, tug assist is one of the most severe environments that a rope can experience. Comprehensive testing and field trials have been conducted, as shown in Figure 1, comparing residual strengths of HMPE lines against the number of jobs performed.

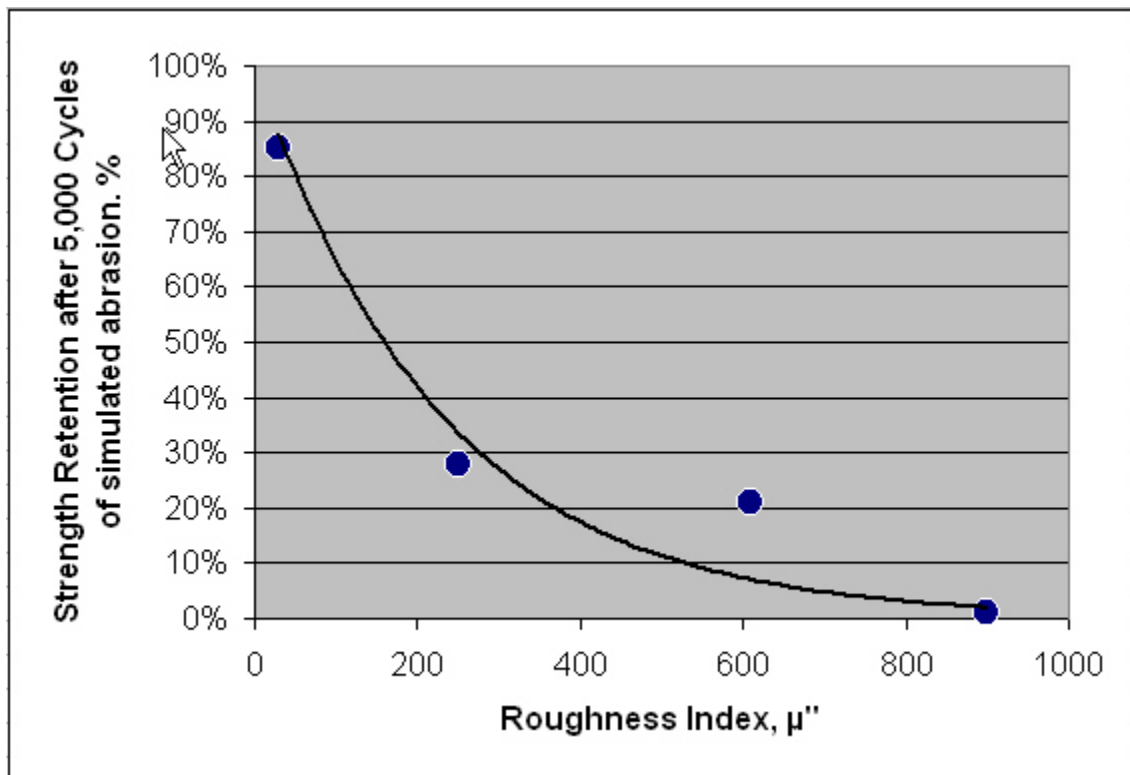
Figure 2. Surface roughness comparison. [2]

In order to protect from this unnecessary damage on board it is recommended that surface roughness of hardware be kept at a maximum of 250 μ'' [2]. This recommendation is supported with testing as shown in Figure 2, showing the effects of a rough surface on rope life.

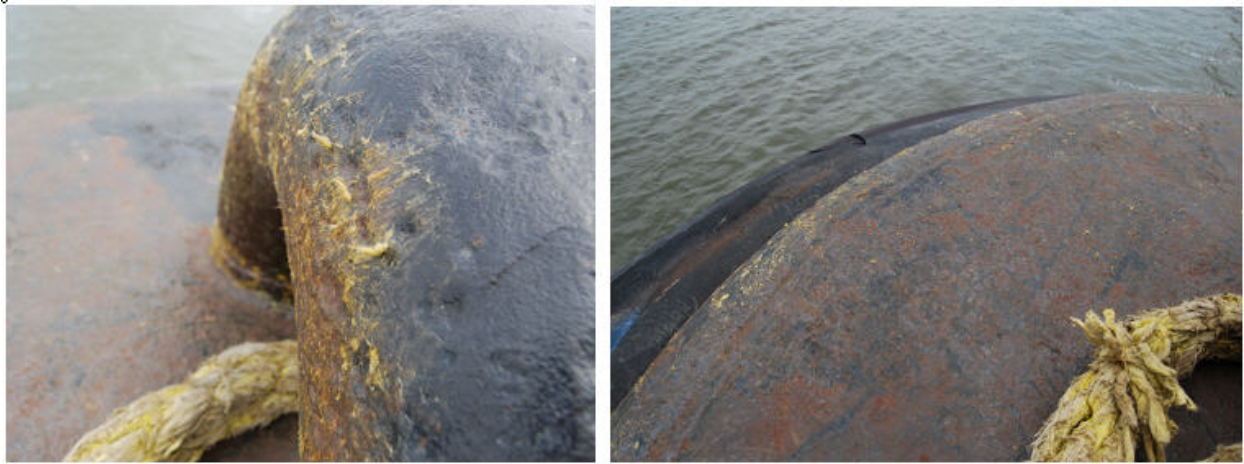
Figure 3. Bull-nose contact surfaces. Rough surfaces cause heavy surface abrasion. [4]

In Figure 3, small amounts of fiber can be seen on the bull nose and lead edge of the tug where rough surfaces have worn the rope's surface. Figure 4 shows a comparison of a stainless-steel-clad staple to a typical "carbon steel" H-bitt. Note the differences in surface roughness and pitting. Even after being painted, these locations on the H-bitt cause a noticeable difference in the condition of the lines that are used on them.

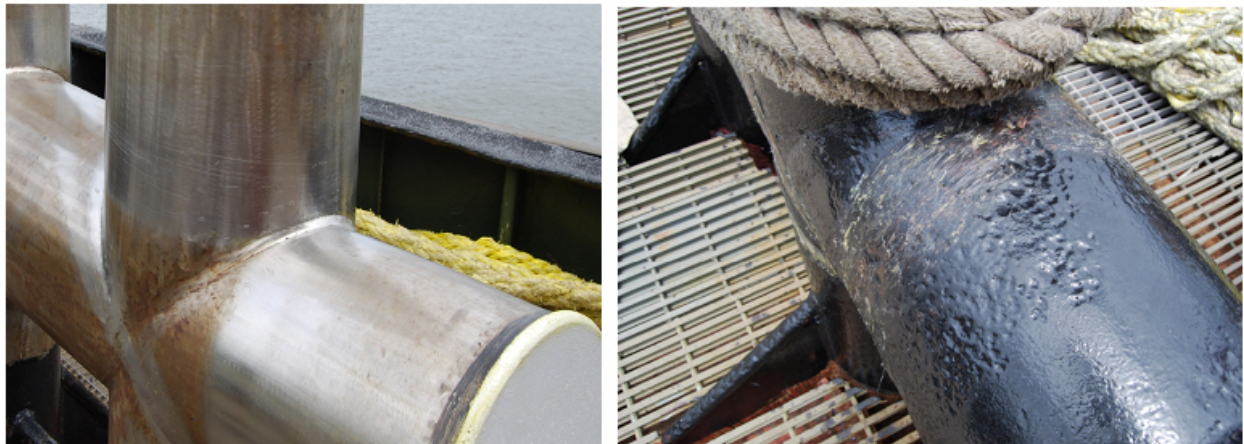
Figure 4. H-bitt comparison. [4]

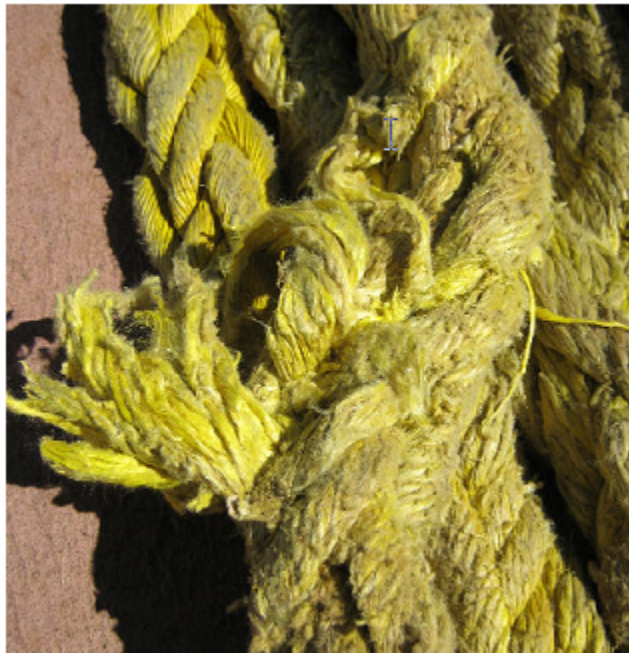
Figure 5. Cut strands. [4]

It is highly recommended that any rope that has suffered adjacent cut strands be retired or repaired by cutting out the damaged section and re-splicing. If a cut line cannot be repaired, it should be treated with caution and replaced as soon as possible. Figure 5 shows an 8-strand rope with a cut strand even though the rope was in otherwise good condition with only moderate surface abrasion.

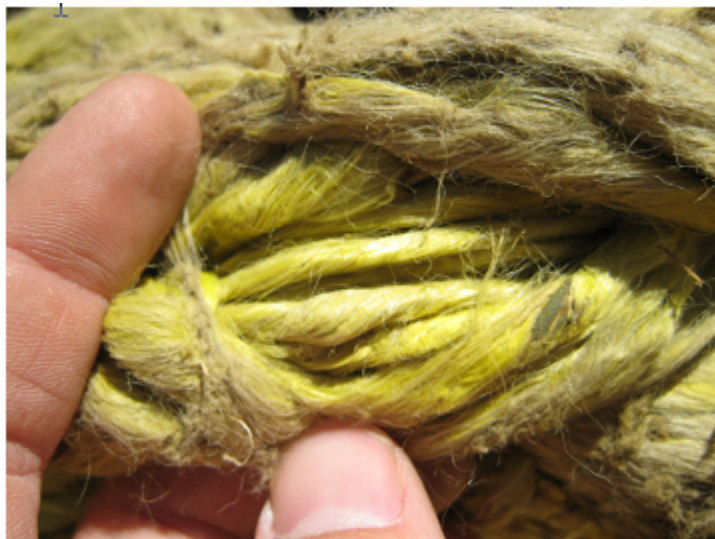
Figure 6. Comparing internal and external yarn condition. [4]

While a rope's outside surface may look rough or damaged, it is important to compare the inner yarns to determine how much abrasion damage has effected the rope's strength. Figure 6 shows internal yarns that are beginning to suffer from moderate internal abrasion, but are still in a serviceable condition.

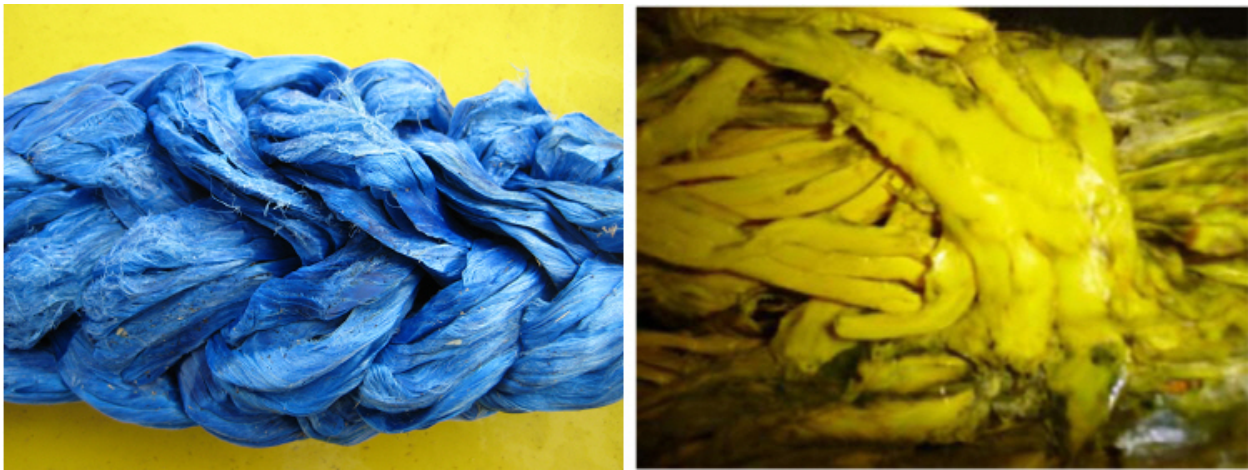
Figure 7. Melted and fused fiber damage. [4]

With any HMPE line, melting damage is a concern. Quick slipping on hardware under high loads can generate a high amount of heat, which can cause yarns or even strands to melt and fuse together, as seen in Figure 7. The fibers/yarns have a glossy appearance and it is no longer possible to separate them by hand. This situation should be carefully guarded against. If the yarns that make up a strand are found to be completely fused that section of the rope should be removed or the entire rope retired.

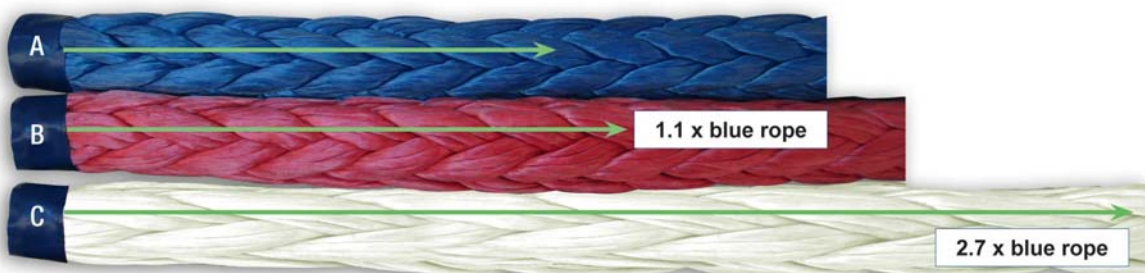
Figure 8. Rope construction comparison. (A) Good firmness and abrasion resistance; (B) 10% looser braid than Sample A; and (C) a very loose braid, difficult to handle, and likely to snag. [4]

An important aspect of rope design that plays a critical role in the rope's abrasion resistance is the braid's cycle length. The length of a single braid cycle in a rope, which is controlled by the braid angle, can vary greatly. This design factor will dictate, among other things, how flexible the rope is to handle. It is possible to adjust the weight and/or strength of a rope by changing the braid period. Figure 8 shows three samples that were tested in order to form a comparison of single braid 12-strand ropes with different braid periods and twist levels.

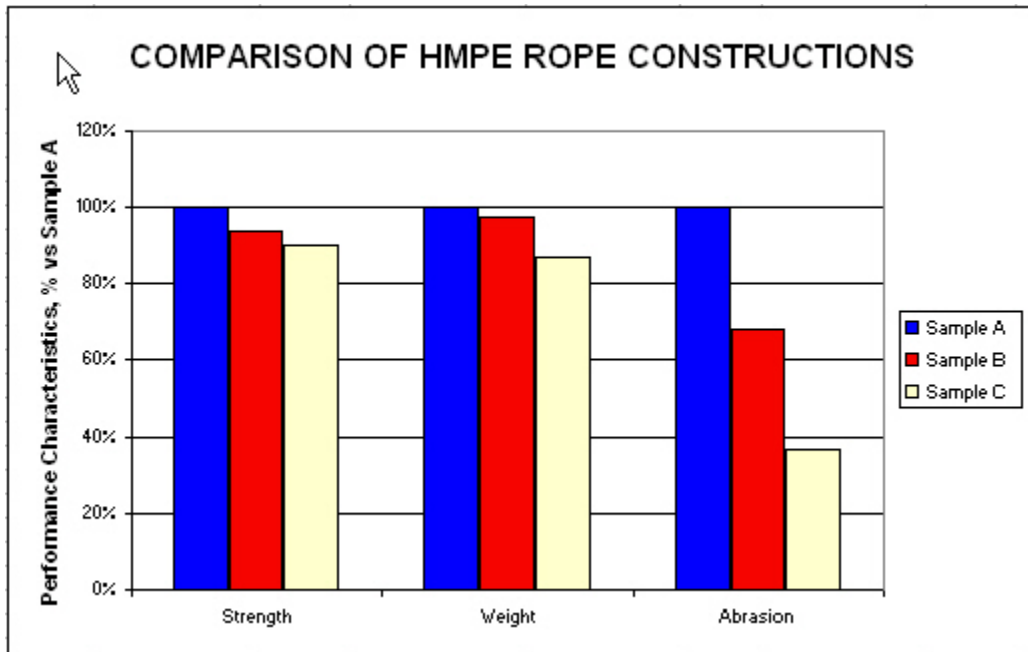
Figure 9. Construction comparison testing. [4]

Figure 9 shows the difference in performance characteristics between the three samples tested. Using Sample A as the control sample, each rope was cycled in a wet abrasion environment under tension until failure occurred. While the weight and strength specifications for each rope were very similar, there was a dramatic difference in abrasion resistance. The loose braid samples had a significant decrease in their ability to resist abrasion damage.

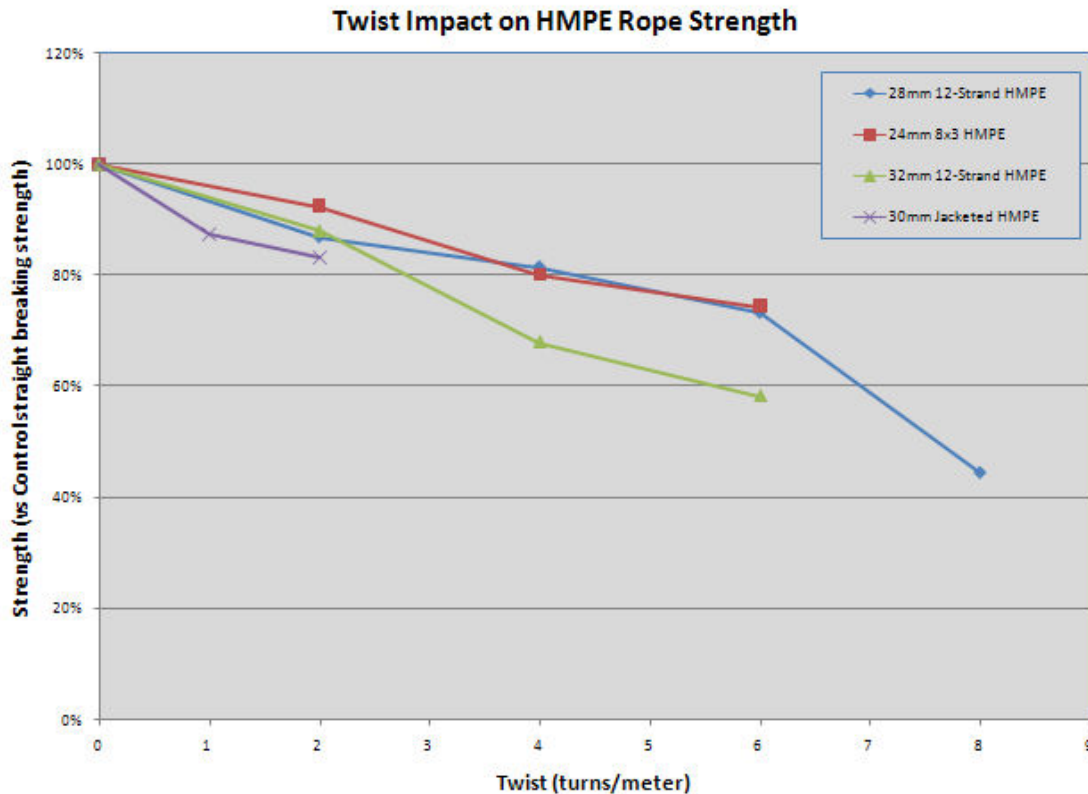
Figure 10. Twist impact on HMPE rope strength.

While abrasion is the primary deterioration mechanism of towline strength, operators should have a high awareness of the negative effects twisting synthetic toelines can have on strength and therefore safety. Figure 10 shows the results of testing to represent the expected strength reduction for HMPE lines when twist is imparted.

It should be noted that while the strength reduction is significant (10–30% for a realistic amount of twist in a typical towline) the problem is even further compounded by the always-present threat from abrasion during standard service.

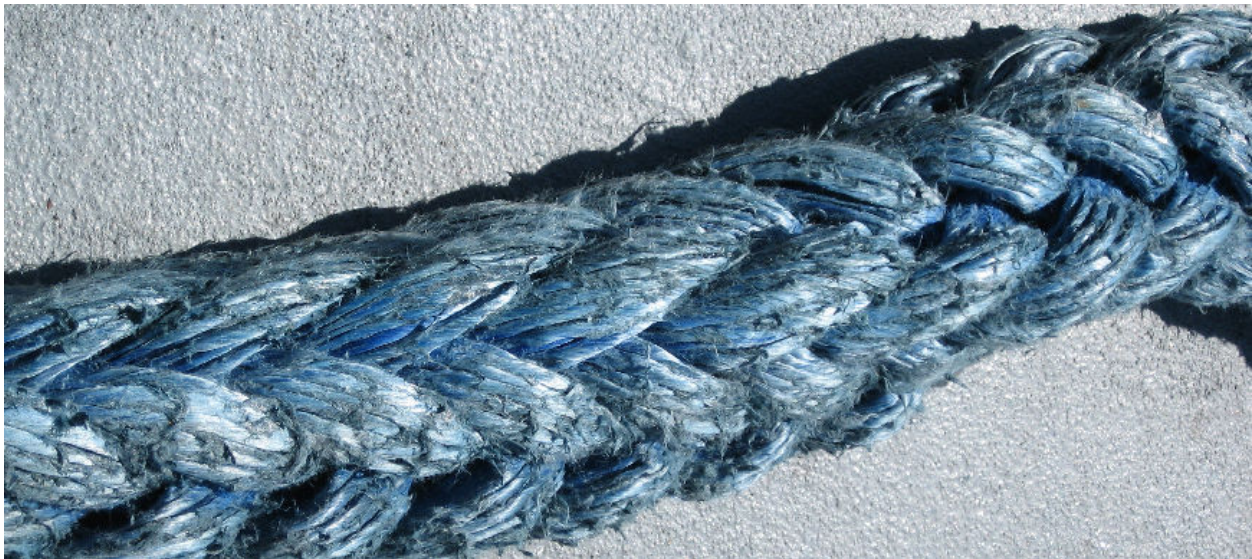
Figure 10 Example of moderate external abrasion. [4]

After just a few weeks in service the outside surface of any rope made from HMPE fiber will begin to appear rough and “fuzzy” (Figure 11). This is due to external abrasion caused by unavoidable contact with rough surfaces such as chocks and/or the vessel’s deck. During service, the strands of a braided rope are constantly being subjected to relative movement. This movement causes damage at the points where strands cross each other, much like the damage caused at positions where the line crosses the chock (Figure 12).

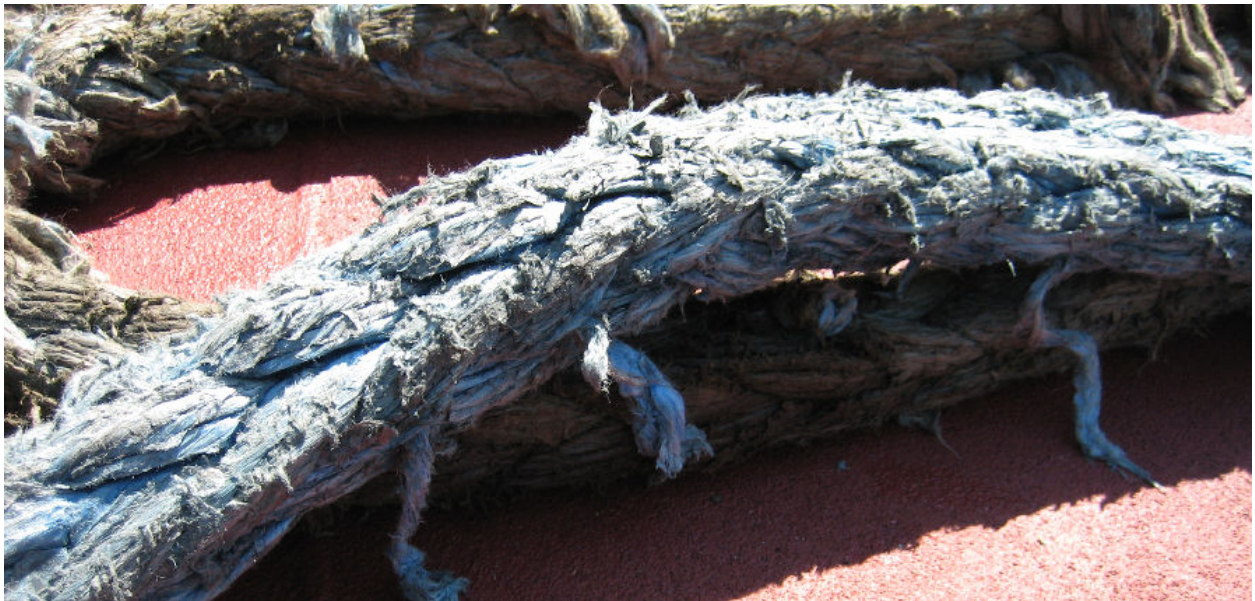
Figure 13. Tug D pendant without chafe protection. This rope has extreme abrasion damage with cut strands. [4]

Figures 13 and 14 show the lines just below the eye splice. Although both lines show some external wear, there is more severe abrasion on the line in Figure 14.

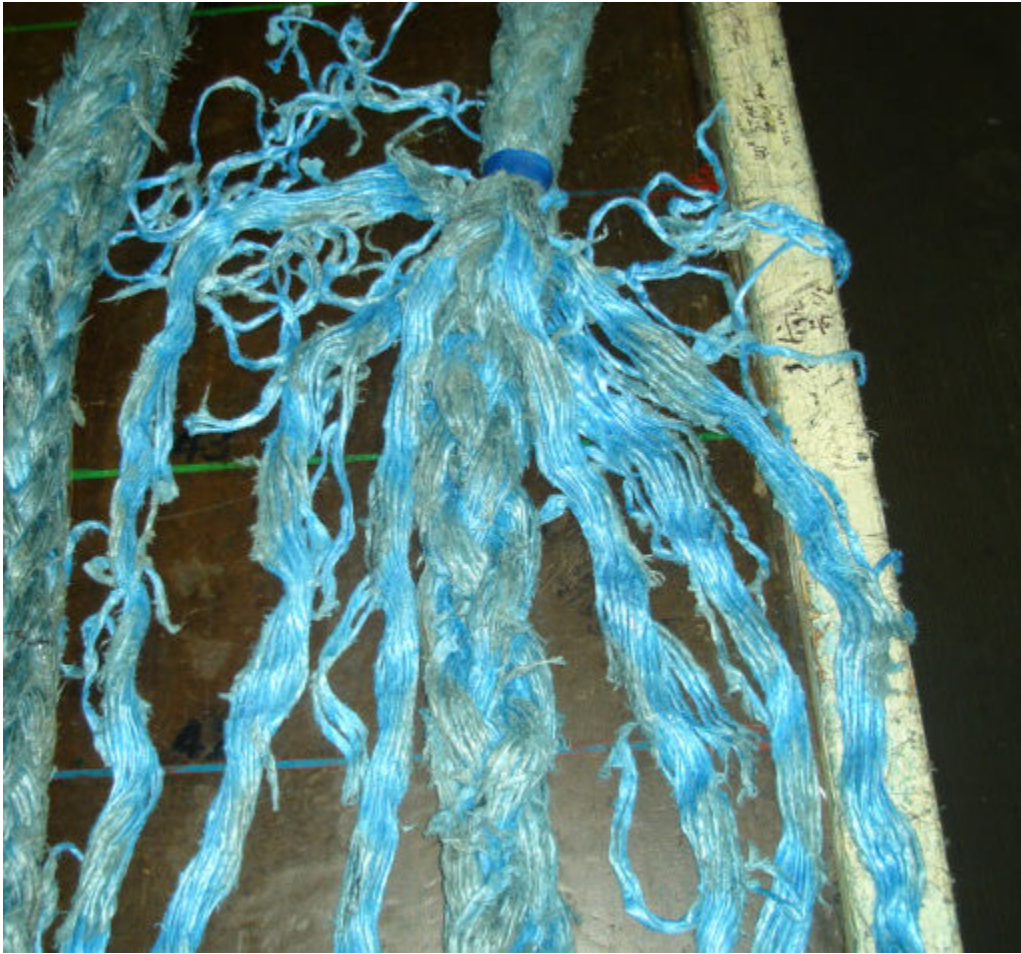
Figure 14. Tug D pendant with cut strands. [4]

When the line from Tug D was inspected, it was evident that the surface abrasion had greatly effected the condition of the rope. The abrasion damage was so severe that a majority of the rope's strands had been at least partially cut or worn through, as shown in Figure 15, with several cut yarns throughout the lay length of the rope.

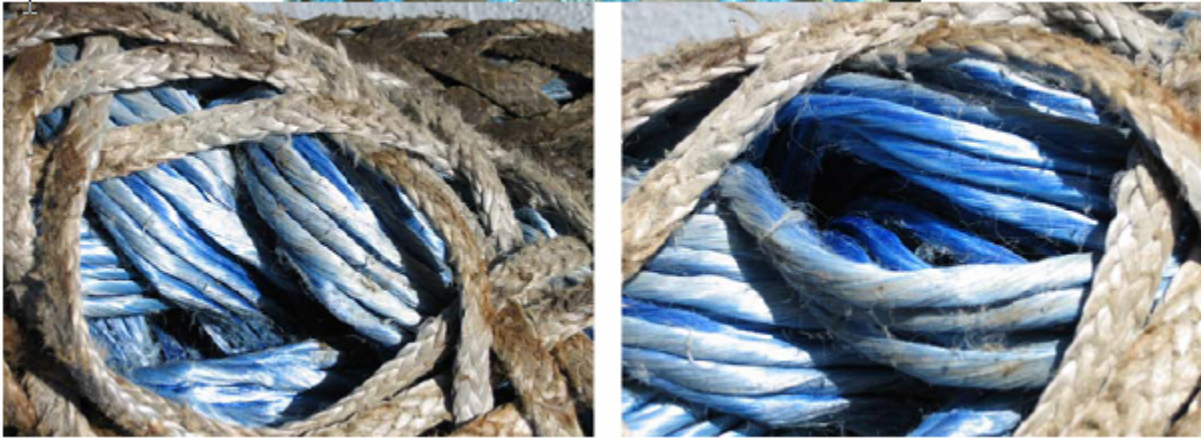
Figure 15. Tug C: Abrasion with chafe protection. [4]

Figures 16 and 17 compare the internal abrasion of the ropes from Tug C and Tug D, respectively. These images show a very important advantage to the proper use of chafe protection. While Tug C had performed 10% fewer jobs than Tug D, it is very clear that the chafe protection used in the eyes of the towline on Tug C significantly reduced the amount of both external and internal abrasion on the line. Looking at the internal strands of each line one can see the strands covered by chafe gear look almost new, while the unprotected strands are fuzzy and worn.

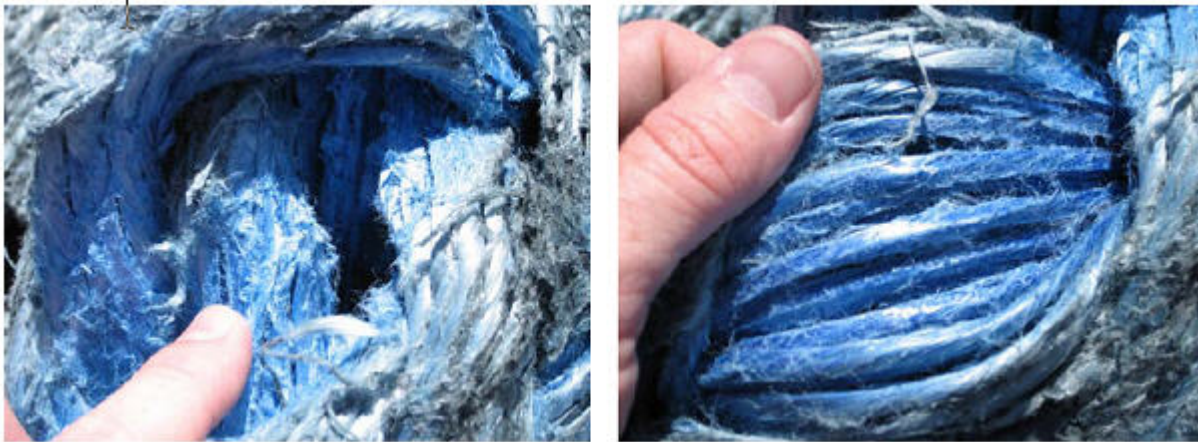
Figure 16. Tug D: Abrasion without chafe protection. [4]

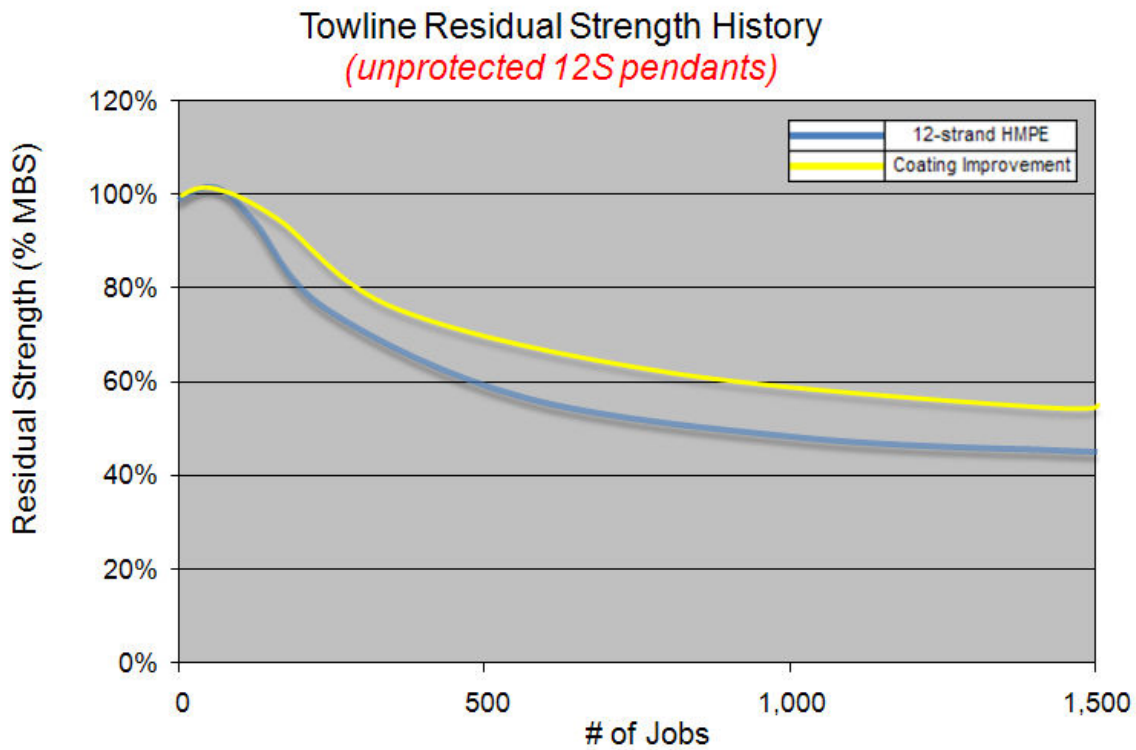
Figure 18. Residual Strength Comparison (coating development).

Testing has been conducted on several harbor-class tractor-tug towlines that use optimized coating technologies for the purpose of establishing the baseline for a new residual strength model. These lines have proven to be the best performers of chafe-protection-free ropes in terms of abrasion resistance. Figure 18 shows this updated model, which demonstrates that an improvement of approximately 15% in the towline’s residual strength can be expected for these pendants being used with no additional forms of chafe protection.
