When Should a Towline Be Retired? Chafe protection and twist and how to recognise their impact

Kris Volpenhein and Robin Collett, Samson, USA

SYNOPSIS

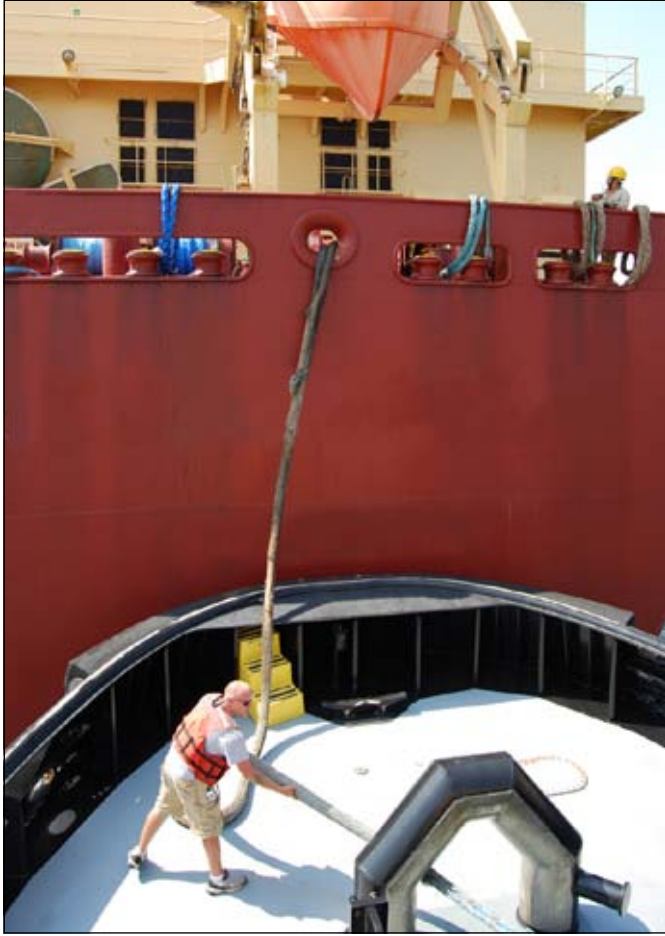
Figure 1 shows a typical ship-assist operation. As can be seen, a specific portion of the towing pendant comes into contact with the deck hardware on board the customer's vessel. This deck hardware is not ideal when using synthetic ropes. In turn, this is the most common location of failures – both in the field and in lab simulation studies. In different applications, other

Figure 1: Typical pendant location during ship assist.

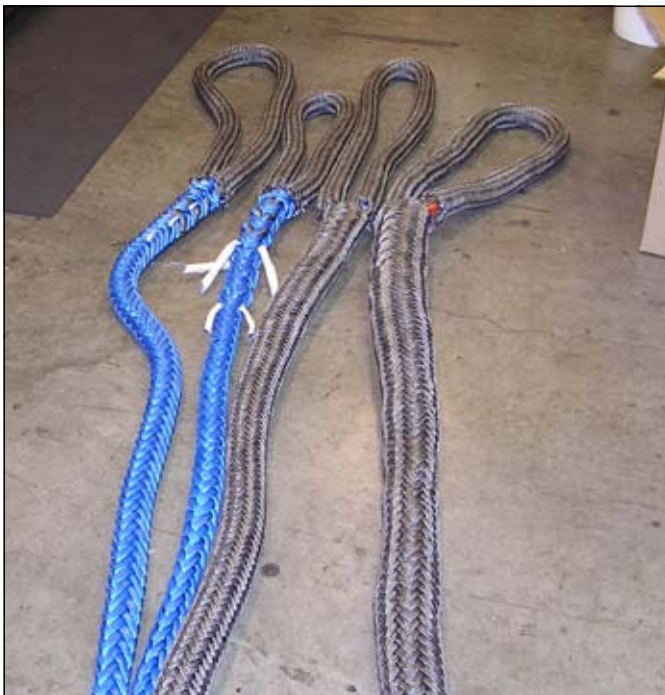
Figure 2 shows two typical towlines with a length of braided chafe gear along a section of the line (as well as within the spliced eye).

Figure 2: Towlines with eye and body braided chafe gear.

This configuration of chafe gear was used on a towing pendant installed on a 6,500hp omni-directional tug. After approximately 1,300 ship assists, the line was retired and returned for inspection and testing. The visual inspection proved the benefits of chafe protection. Figure 3 shows the protected end of the line, with minimal effects of abrasion. Figure 4 shows the typical wear on the unprotected end of the line, both internal and external.

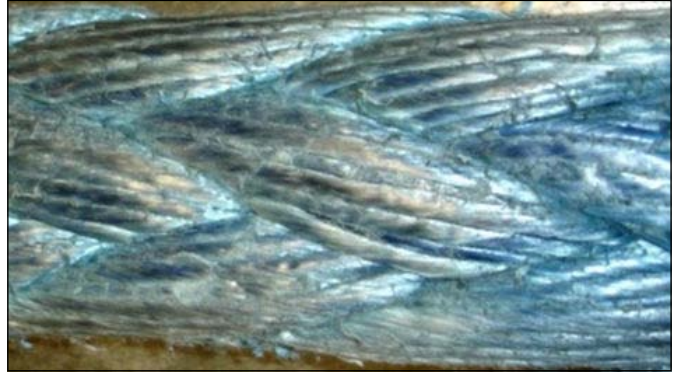
Figure 3: The protected portion of the pendant.

While the protected end of the pendant showed little sign of serious damage and had a predicted residual strength of 65–75 per cent, when tested, the pendant broke at a load of 51 per cent of the new-rope minimum breaking strength, and broke in the most severely damaged area. From this, it should be noted that severe localised abrasion is a serious concern in all towing applications and can create a weak link in a rope that may otherwise be in good condition.

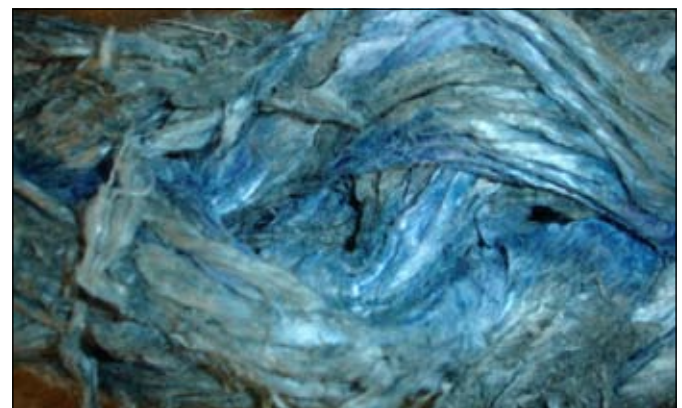
Figure 4: An unprotected portion of the pendant.

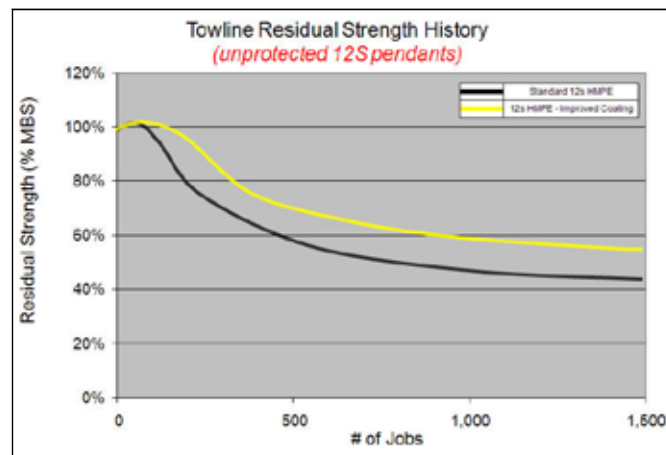
The plot in Figure 6 shows a combination of two residual strength models for HMPE towing pendants. As reported in Ref 1, the black line is a representation of

the predicted residual strength of a “standard” 12-strand HMPE towing pendant throughout its service life. The yellow line is a preliminary model for the residual strength of 12-strand HMPE pendants coated with the new coating technology.

Figure 6: Residual strength model comparison.

By greatly reducing the degradation caused by internal abrasion (yarn-on-yarn and strand-on-strand), this new coating has allowed these towing pendants to operate at a higher safety factor by increasing their residual strength by as much as 15 per cent after approximately 400-800 jobs (over previously tested pendants on similar applications/vessels) This improvement allows not only increased operating safety, but also the shift in the curve shows that the line could remain in service for a longer period of time before reaching the same residual strength.

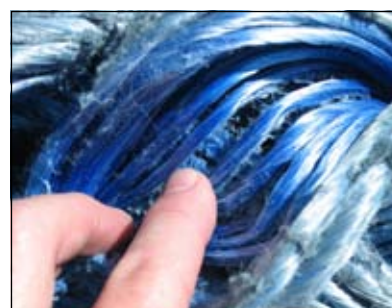
Figure 7(a) shows the internal condition of a typical 12-strand HMPE towing pendant after several months in service. Notice the wear or fuzzy appearance that has started on the yarn level, and compare it with the 12-strand pendant treated with the improved coating in Figure 7(b). There is a significant reduction in yarn-on-yarn damage on the treated pendant.

Figure 7(a): Internal wear on a standard 12-strand pendant.

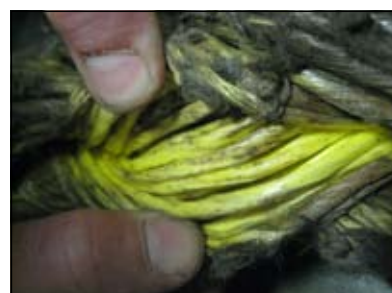
Figure 7(b): Reduced internal wear on a 12-strand pendant with improved coating.

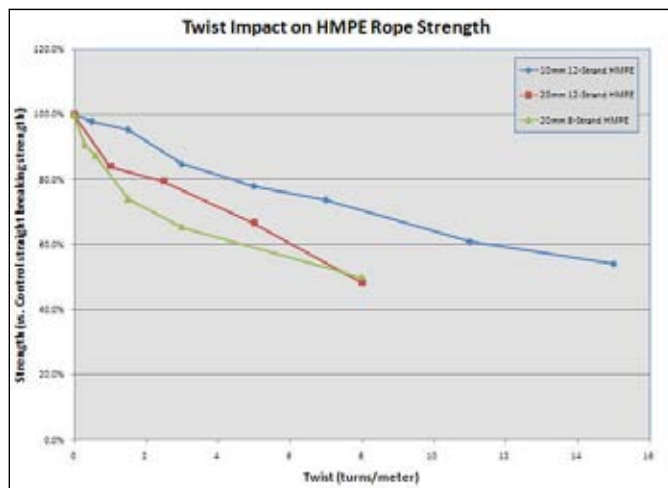
While abrasion is the primary deterioration mechanism of towline strength, operators should have a high awareness of the negative effects that twisting synthetic towlines can have on strength and, therefore, safety. Figure 8 shows the results of scaled testing that represents the expected reduced strength for HMPE lines when twist is imparted in lines under tension.

Figure 8: Twist impact on HMPE rope strength.

It should be noted that, while the strength reduction is significant (10–30 per cent for a potentially realistic amount of twist in a typical towline), it is not necessarily a predictive tool. The strength reduction caused by twist and abrasion are not strictly cumulative and a more extensive study would be required to determine the real-life strength reduction that could be expected with several different levels of twist and abrasion damage.

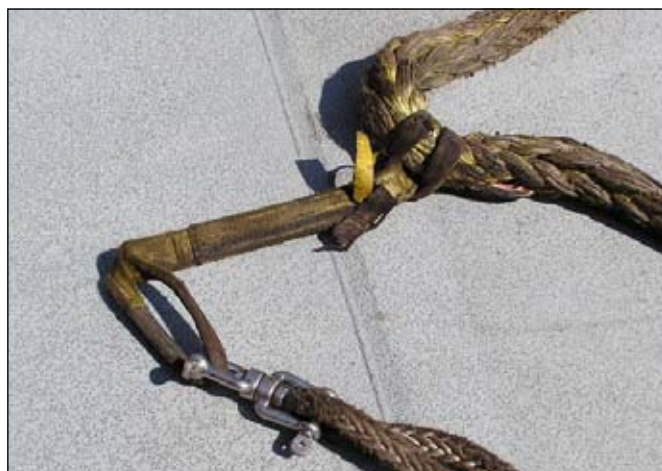
handling by crew members on the client vessels. One such method is shown in Figure 10. The tagline swivel used to attach the mainline to the messenger line limits the amount of twist transferred from the messenger line to the mainline, regardless of how the line is handled by crew members.

Figure 10: Tagline swivel.
