UNITED STATES COAST GUARD

INVESTIGATION INTO THE CIRCUMSTANCES
SURROUNDING THE SINKING OF THE

TUG VALOUR

40 MILES OFF THE COAST OF WILMINGTON, NORTH
CAROLINA ON JANUARY 18, 2006 WITH MULTIPLE
LOSS OF LIFE

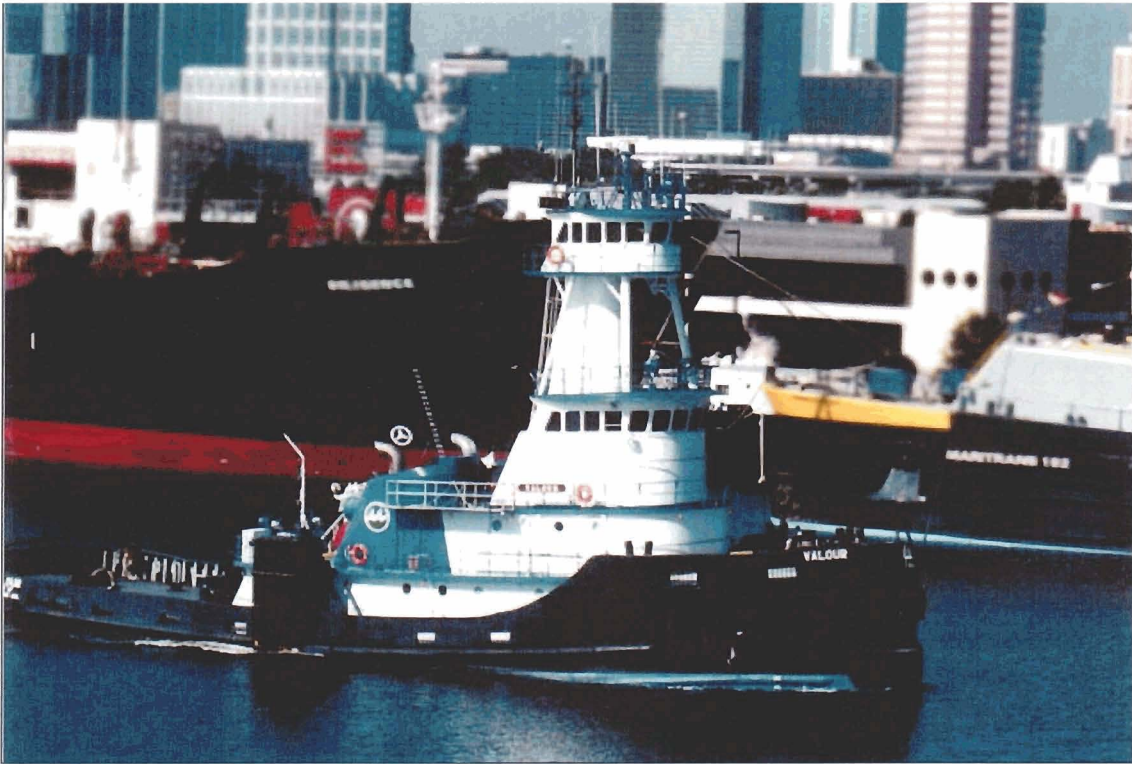
Photograph of the VALOUR prior to the incident

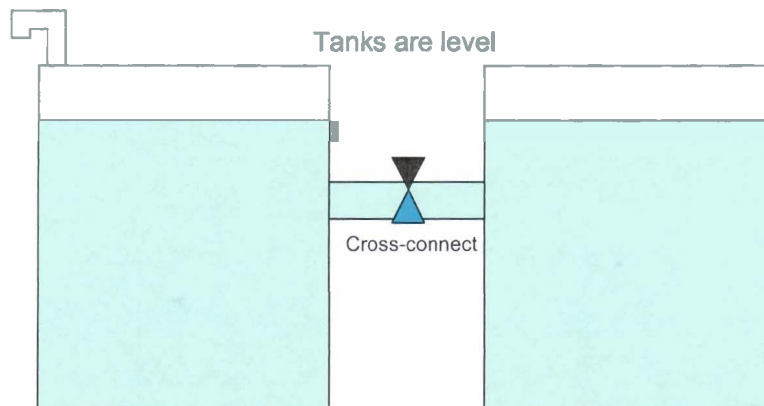
to approximately 6% of the permeable volume. Based upon the static angle of heel, limited righting energy, and submergence of the aft deck, the VALOUR would have had negligible stability and probably could not have stayed upright in the 12-20 ft seas reported at the time of the casualty. Once the VALOUR heeled over enough for continuous downflooding through the port engine room vents, sinking was inevitable. Determining the amount of time it takes for pairs of tanks to hydrostatically balance is difficult, especially taking into account the unknown but extreme vessel roll dynamics at the time of the casualty. However, assuming the difference in the fluid levels of the largest pair of tanks (#5 port and starboard fuel tanks) was 5 ft and the tanks were connected by a straight 10 ft section of 2.5 inch diameter pipe, the maximum initial flow rate would be approximately 210 gallons per minute. The modeling indicated that in balancing between successive conditions, a pair of tanks would need to transfer at most 2,700 gallons. Given the assumptions above, which are not exact to the actual conditions on the VALOUR, the balancing time would be at least 13 minutes. In practice it would take longer because of the differences in head pressure, piping diameters, piping configuration, the presence of multiple fittings, and the quantity of liquid to be transferred.
